**CWA OVERSIGHT INSPECTION REPORT  
ILLINOIS**

<b>Inspection facility</b>	Meier Land and Cattle, LLC 3568 East McConnell Road Dakota, Illinois 61018
<b>NPDES permit status</b>	ILA010071
<b>IEPA inspection date</b>	04/24/13
<b>EPA inspection date</b>	09/17/13

**CWA COMPLIANCE EVALUATION INSPECTION REPORT**  
**U.S. ENVIRONMENTAL PROTECTION AGENCY, REGION 5**

Meier Land and Cattle, LLC

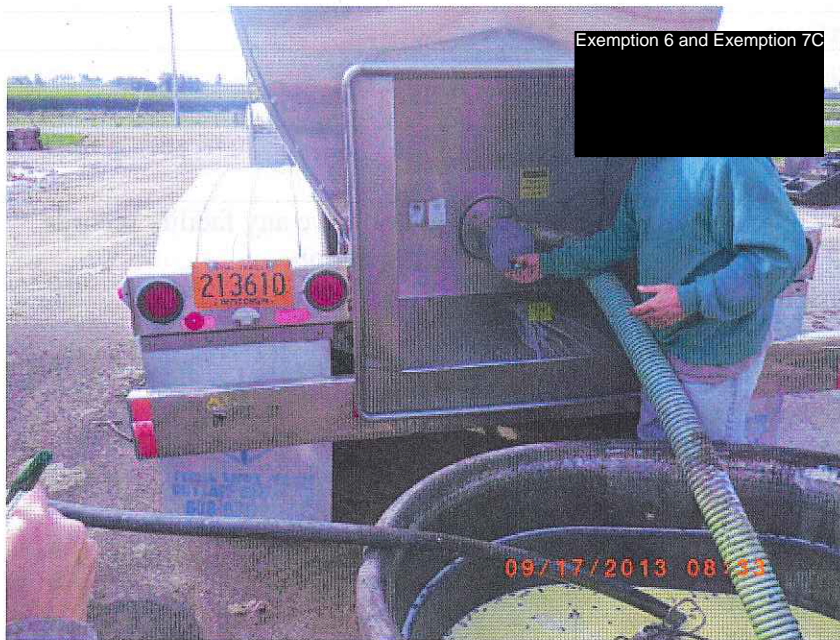
IMGP0212: Mr. Meier constructed a cap for the pipe connection that can be locked with a padlock to prevent unauthorized release of DLP from the tanker truck.

Before the arrival of the cement truck, EPA discussed the work that Mr. Eugene Meier had done as a response to the inspection by IEPA on April 24, 2013. In that inspection, Mr. Heeren identified the potential for discharge from the 6000 gallon tanker that sat on the facility driveway. The tanker held delactosed permeate (DLP), a protein by-product of whey. Mr. Heeren was concerned that a spill or vandalism on the tanker valve could cause a discharge to the intermittent unnamed tributary of Cedar Creek and then to Cedar Creek. Since then, Mr. Eugene Meier had fashioned a locking mechanism on the valve so it couldn't be tampered with.

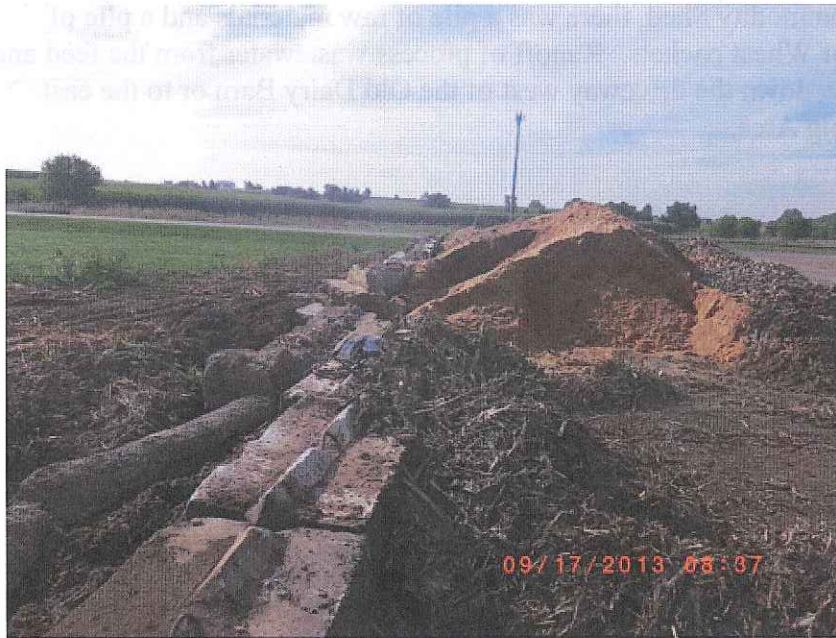
IMGP0217: Concrete blocks had been placed on the east side of the mixing area to prevent runoff to the intermittent unnamed tributary. Agricultural lime was placed on the west side of the blocks and dirt on the east side. The blocks were moved in preparation for the concrete delivery. Feed is temporarily stored here while the South Commodity Shed pad was being poured.

Mr. Eugene Meier had also placed concrete blocks on the east side of the driveway with a berm of agricultural lime in front of the blocks to prevent process wastewater from the driveway and concrete pad from flowing with precipitation to the intermittent unnamed tributary of Cedar Creek. The blocks had been partially moved to allow for the cement work to continue. The Meiers had also torn down an old commodity shed that was located on the west side of the driveway.

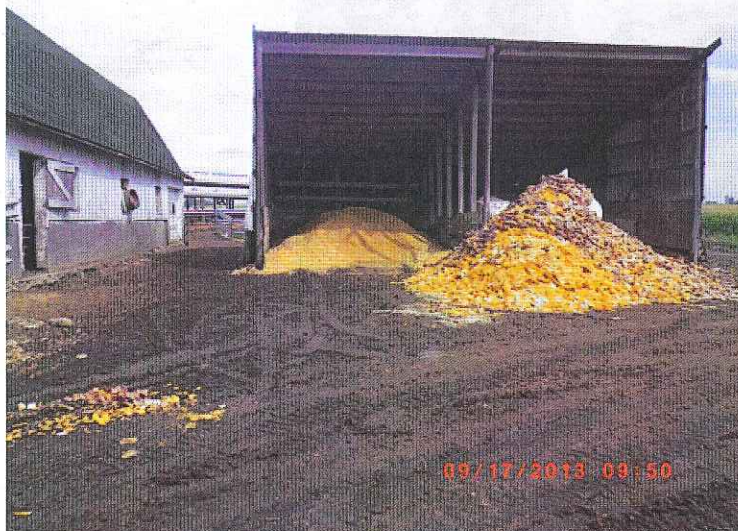
In front of the North Commodity Shed, there was a pile of raw materials and a pile of taco shells and Cream of Wheat packets. Runoff of process wastewater from the feed and raw materials could flow down the driveway west of the Old Dairy Barn or to the east and to the Cattle Working Area.

IMGP0220: North Commodity Shed has a pile of taco shells and Cream of Wheat packets out in the open. Runoff from this area could flow with precipitation either down the driveway west of the Old Dairy Barn or to the east and through the Cattle Working Area. Location: North of Old Dairy Barn Facing: North Date/Time: 09/17/13 10:50 A.M.

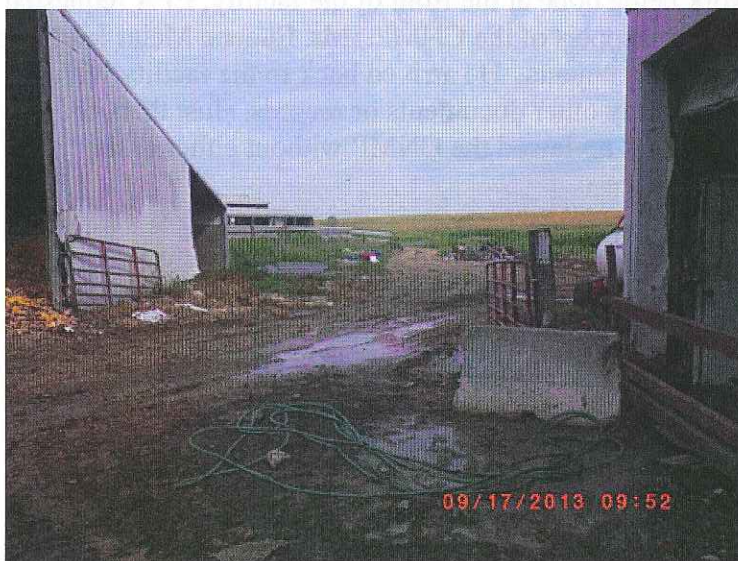
IMGP0222: Precipitation pathway from the North Commodity Shed to the east. Location: North of Old Dairy Barn Facing: North Date/Time: 09/17/13 10:52 A.M.

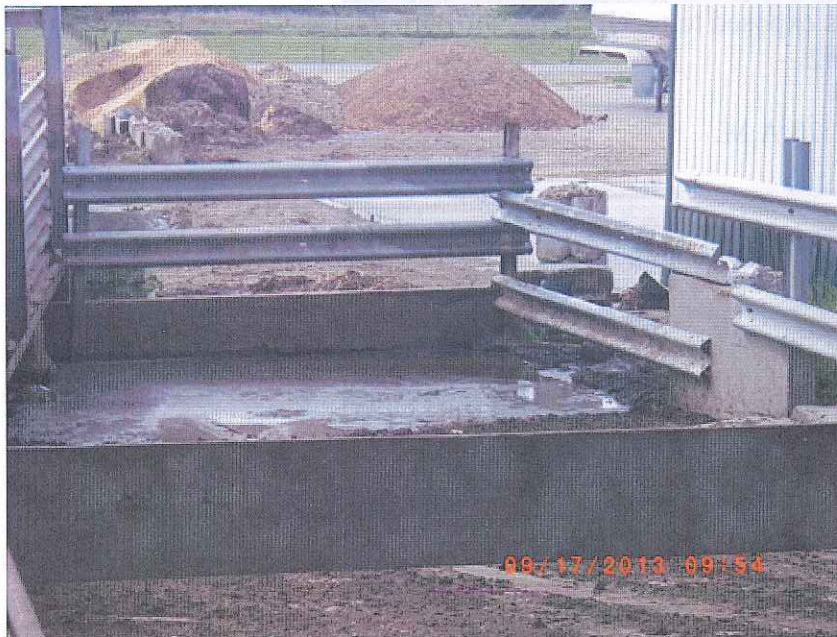
Mr. Eugene Meier joined EPA and IEPA and explained that precipitation that falls on the roof of Barn #1 and on the Cattle Working Area would flow out at that location. From there it would flow to the vegetated area to the east of the concrete pad for the southern commodity shed. The intermittent unnamed tributary of Cedar Creek is approximately 275 feet to the southeast of the relief point in the wall of the Cattle Working Area. Mr. Meier stated that it would be very difficult to scrape the Cattle Working Area because the concrete floor was cracked.

IMGP0229: Southwest corner of the Cattle Working Area where manure and process wastewater are not contained.

1. Manure and process wastewater could flow out of the Cattle Working Area at the southwest corner to the vegetated area and then to the intermittent unnamed tributary of Cedar Creek. The intermittent unnamed tributary is approximately 150 feet to the southwest.
2. Process wastewater from the mortalities that were placed on the bank of the intermittent unnamed tributary would flow to the tributary.
3. The berm of the Manure Storage Pond was being eroded from the flow of manure being pumped to the pond from the under barn pits.
4. The vegetation on the berm of the Manure Storage Pond was not mowed and there were holes from burrowing animals in the berm.

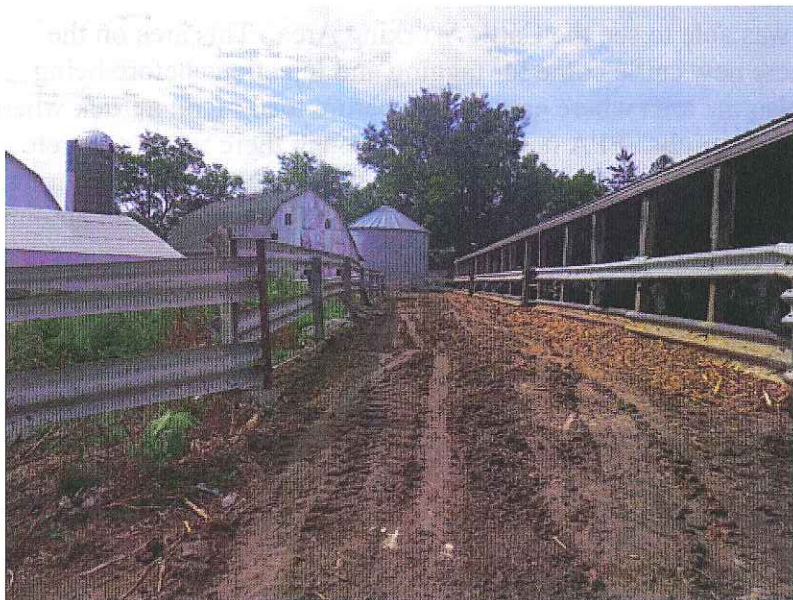
IMGP0236: Feed lane is exposed to precipitation for Barn #2.

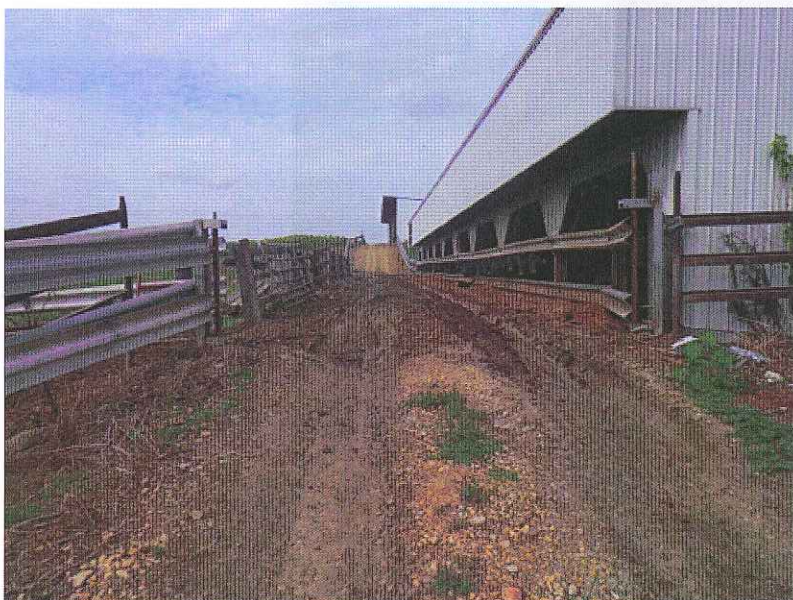
IMGP0240: South side of Barn #3. Feed in feed lane is kept under roof overhang.

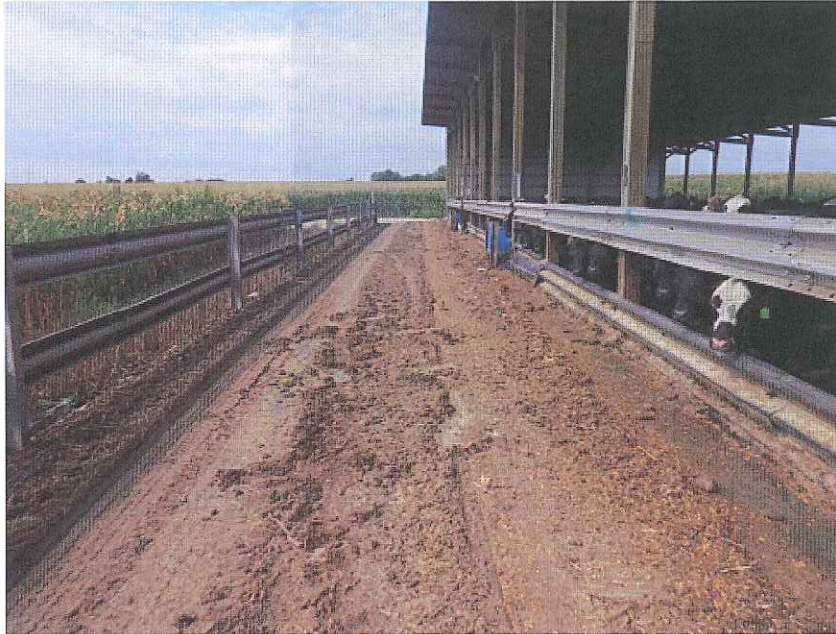
IMGP0244: South side of Barn #4. This barn has a ten foot pit that is pumped out and directly land applied twice per year. The feed is covered somewhat by an overhang of the roof.

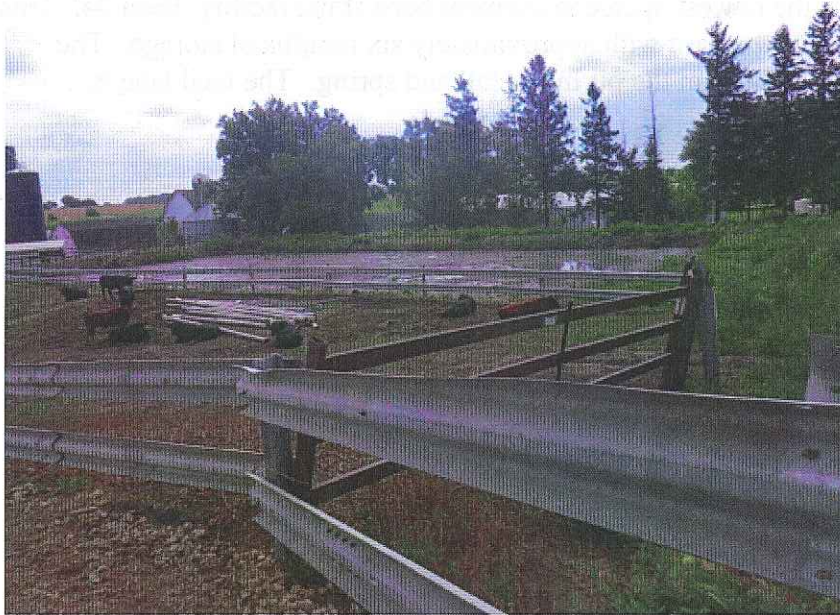
IMGP0243: Injured animals are confined in the space north and east of the Manure Storage Pond. They are also able to access an area south of the Manure Storage Pond.

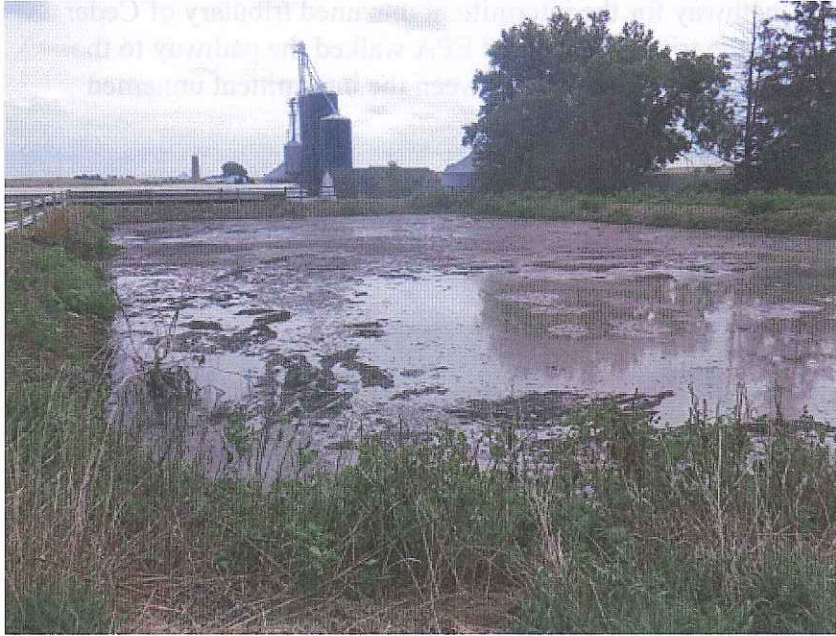
IMGP0245: The Manure Storage Pond appeared to have about four feet of freeboard.  
 Location: Northwest corner of the Manure Storage Pond  
 Facing: Southeast  
 Date/Time: 09/17/13 11:37 A.M.

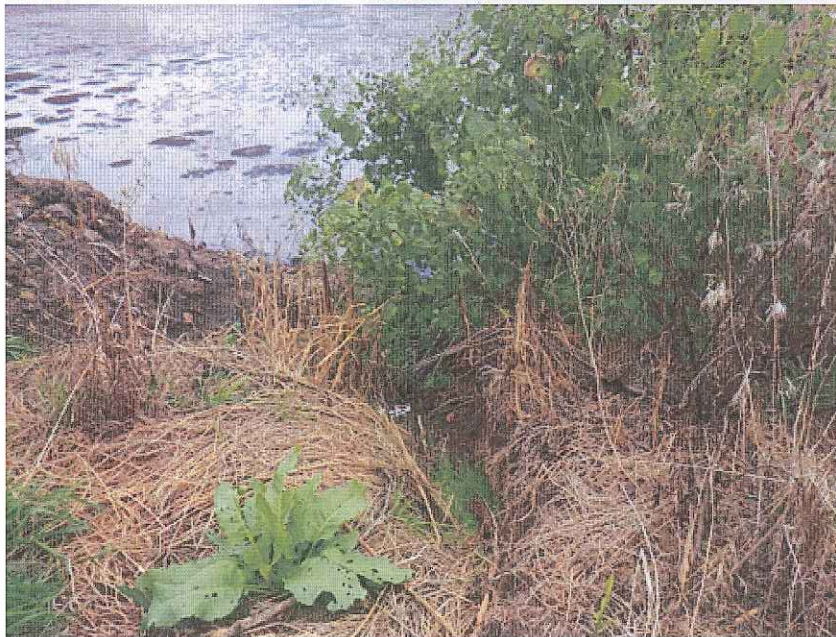
EPA walked around the berm of the Manure Storage Pond. In the locations where the manure was pumped to the pond, the berm had been eroded and there were gouges in the berm wall. EPA also noted a couple of burrowing animal holes. The vegetation on the berm was not kept short and EPA estimated that there was approximately four feet of freeboard in the pond. The depth marker was located on the north side of the pond.

IMGP0247: Erosional feature from where hosing is laid when manure is pumped to the Manure Storage Pond.  
 Location: Southeast corner of the Manure Storage Pond  
 Facing: Northwest and down  
 Date/Time: 09/17/13 11:39 A.M.

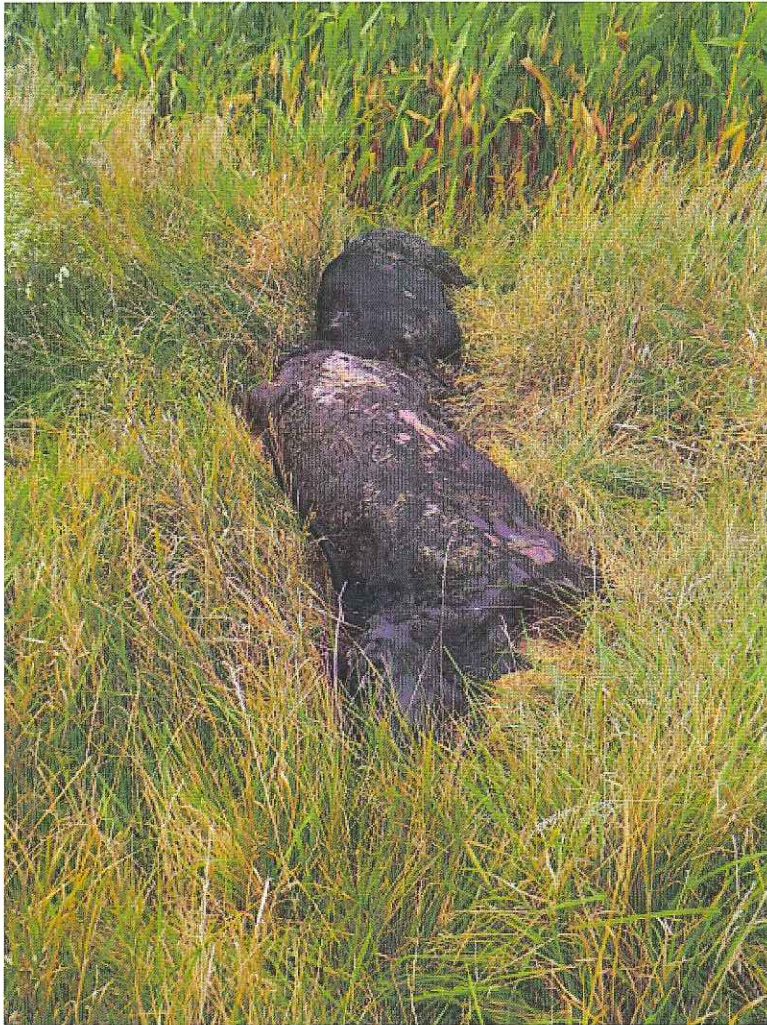
At the southeastern corner of the corn field, EPA observed two dead cattle that had been placed on the bank of the waterway. The cattle were in an advanced state of decomposition and there were pools of maggots around the carcasses.

IMGP0251: EPA walked down the (dry) intermittent unnamed tributary from east of Barn #2 to Cedar Creek. Southeast of Barn #1, EPA observed two dead cattle lying on the bank of the tributary.

EPA walked to the concrete pad for the South Commodity Shed where Mr. Heeren, Mr. Eugene Meier and Mr. Matthew Meier were waiting. EPA stated that two mortalities were found on the bank of the intermittent unnamed tributary. Mr. Eugene Meier stated that they put the mortalities there because the animals died on the previous Friday in 90°F temperature and the rendering service did not pick up animals until Monday. He also stated that he hoped that we wouldn't see them during the inspection. EPA advised him to bury the mortalities immediately, especially since a significant rain was forecasted for the following day.

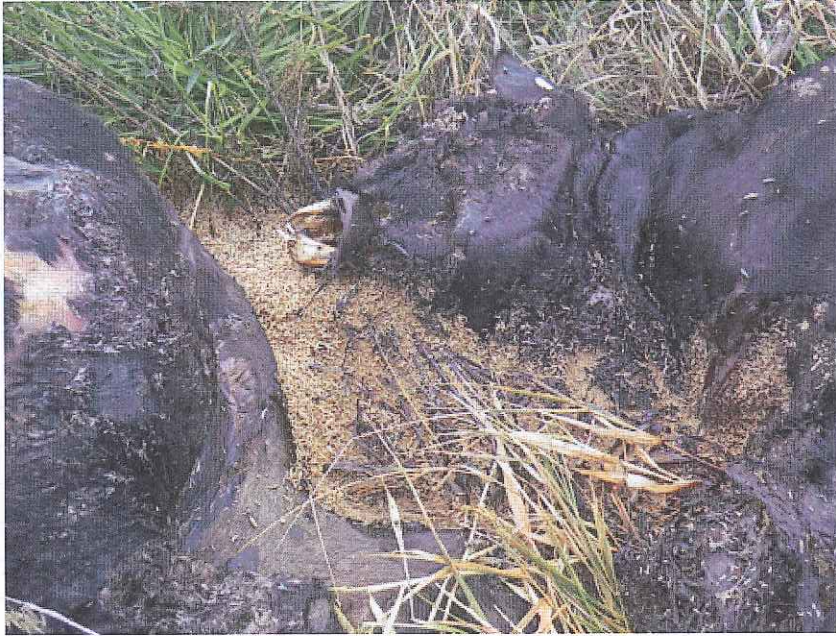
IMGP0253: Mortalities were covered with maggots.
